# Head Gaskets (1)

by Tom Endy

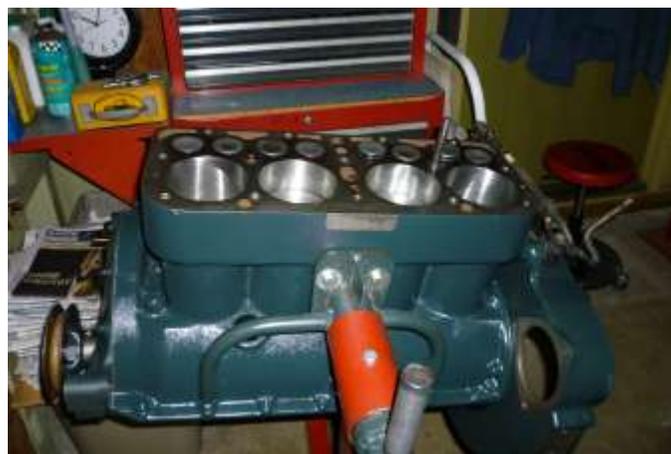
The #8 stud sits right next the narrow area between the #3 and #4 cylinders where the head gasket is very narrow and susceptible to blowing. The area between #3 and #4 cylinders is the most common area for a head gasket to blow even when there is

**The #8 stud sits right next to the narrow area between #3 and #4 cylinder.**

The best solution is to remove the clamp completely from the armored cable and install a spacer under the nut at the #8 stud to properly space it. Torque all the head bolts down to the proper specification in sequence, and don't fool with them when out on the road. The #8 stud can also be replaced with a standard length stud as used in the other stud positions.

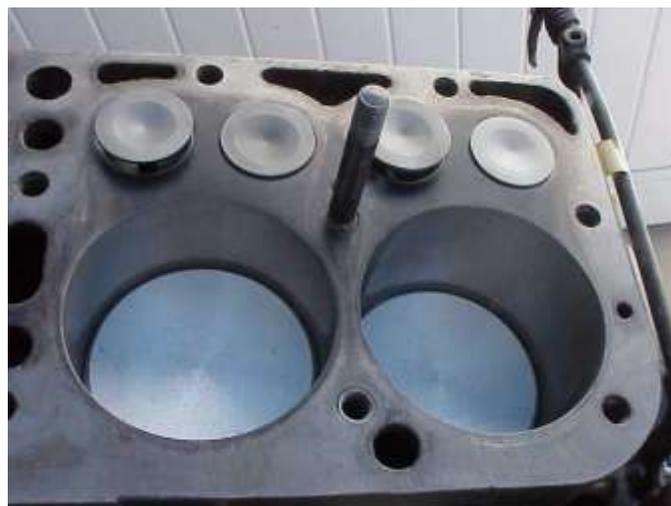
proper torque on the stud. Removing the nut at #8, or running without the spacing of the clamp only adds to the possibility of blowing a head gasket and warping the head.

**The area between #3 and #4 cylinder is a common place for a blown head gasket. The #8 stud sits right next to the area.**
